ESTCP Cost and Performance Report

(WP-200906)

Non-Chromate, ZVOC Coatings for Steel Substrates on Army and Navy Aircraft and Ground Vehicles

December 2014

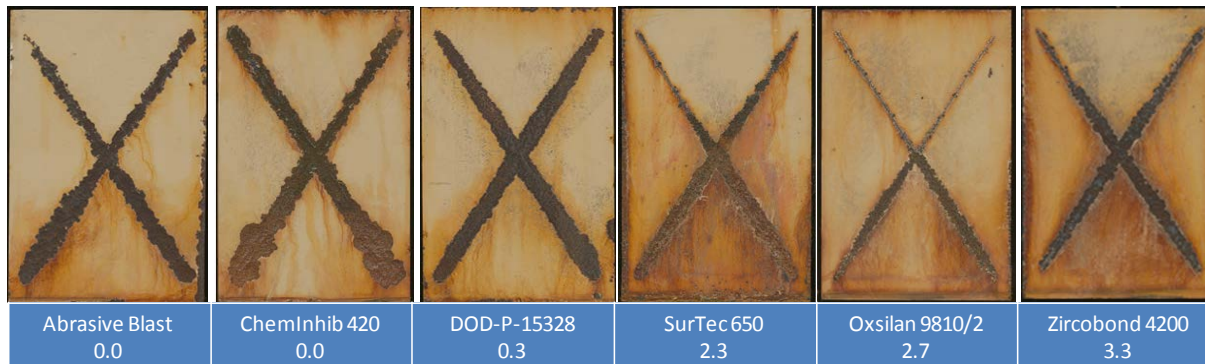
Figure 6. Average ratings of HHA test panels scraped after 80 cycles of GM 9540P with MIL-DTL-53022/MIL-DTL-53039 CARC.

Sets of panels with two CARC coating systems, MIL-DTL-53022 / MIL-DTL-53039 and MIL-DTL-53022 / MIL-DTL-64159 were tested in GM 9540P cyclic corrosion. Replicates of three were used for the GM 9540P tests for each pretreatment and baseline. Table 6 lists the ratings averaged over the three replicates. The success criterion is an average ASTM 1654 rating of ≥ 4 for “X” scribed panels at 60 cycles. The test was carried out to 80 cycles before scraping the panels for a final rating. Similar to the ASTM B117 results, only the alternative pretreatments were able to meet the required ≥ 4 . The only exception was the Zircobond 4200 coating with DTL-53022 / MIL-DTL-64159 where one of the three panels in the set rated a three dropping the average rating below four. Even with an average of 3.7, the Zircobond performed better than any baseline with either coating system. When the test reach 80 cycles and the panels were scraped and measured, all of the controls (abrasive blast only), and nearly all baselines and control test panels rated a zero or near zero. Photographs of representative panels are in Figures 6 and 7. The

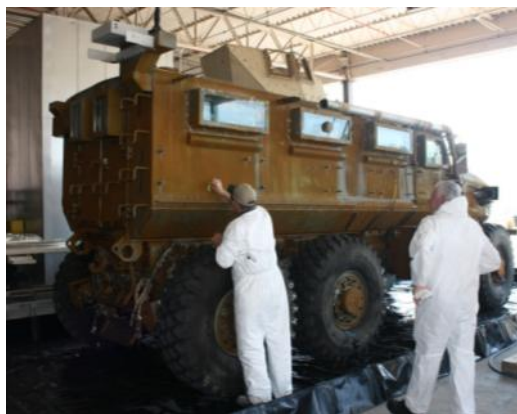
Figure 11. MRAP #1 after application of with Oxsilan 9810/2, June 20, 2011.

Figure 11 shows MRAP #1 after the application of the Oxsilan 9810/2. These results were completely unexpected and bear no resemblance to the surface finish that was achieved on the earlier demonstration on Stryker hatches treated Oxsilan 9810/2 at ANAD (see Figure 9).

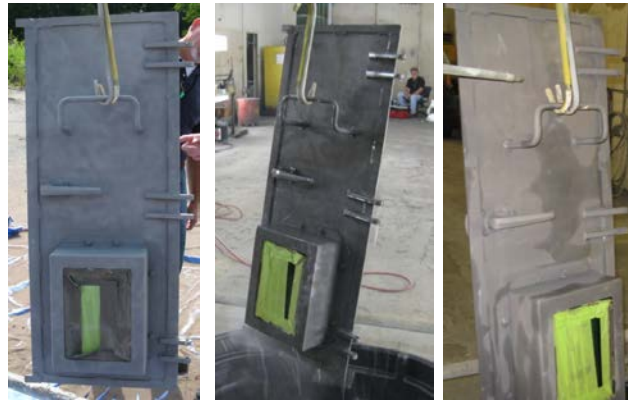
Figure 13. MRAP rear doors.

(left: freshly abrasive blasted, center: during application of Oxsilan 9810/2, right: drying)

To prove our hypothesis, ARL worked closely with the MRAP-PMO to secure another demonstration of a limited scope. The MRAP-PMO agreed to provide one set of two rear doors from an MRAP variant for pretreatment using Oxsilan 9810/2. During this demonstration, we were very cognizant of the mistakes made at Camp Lejeune. Therefore, two improvements were made over the process used at Camp Lejeune: 1) the freshly abrasive blasted doors were pretreated with Oxsilan 9810/2 within 2 hours of blasting, and 2) adequate flow of the pretreatment solution was achieved by using a Yamada NDP-15 BPT pump with a 4.0 gpm rating. The Oxsilan treated surfaces of the door looked similar to the results seen at ANAD during the Stryker hatch demonstration. As can be seen in Figure 13, they appeared light grayish blue. No reddish/brown discoloration occurred anywhere on the door. The application of the Oxsilan was carried out similar to the Stryker hatches at ANAD. The surfaces were treated with Oxsilan less than 2 hours after abrasive blasting using a pump sprayer with adequate flow to keep the surfaces wet throughout the pretreatment process. This is added evidence that the
